Case Study

# Derbion Shopping Centre

Derby

AlphaGuard PUMA  
Liquid Applied Flat  
Roofing System

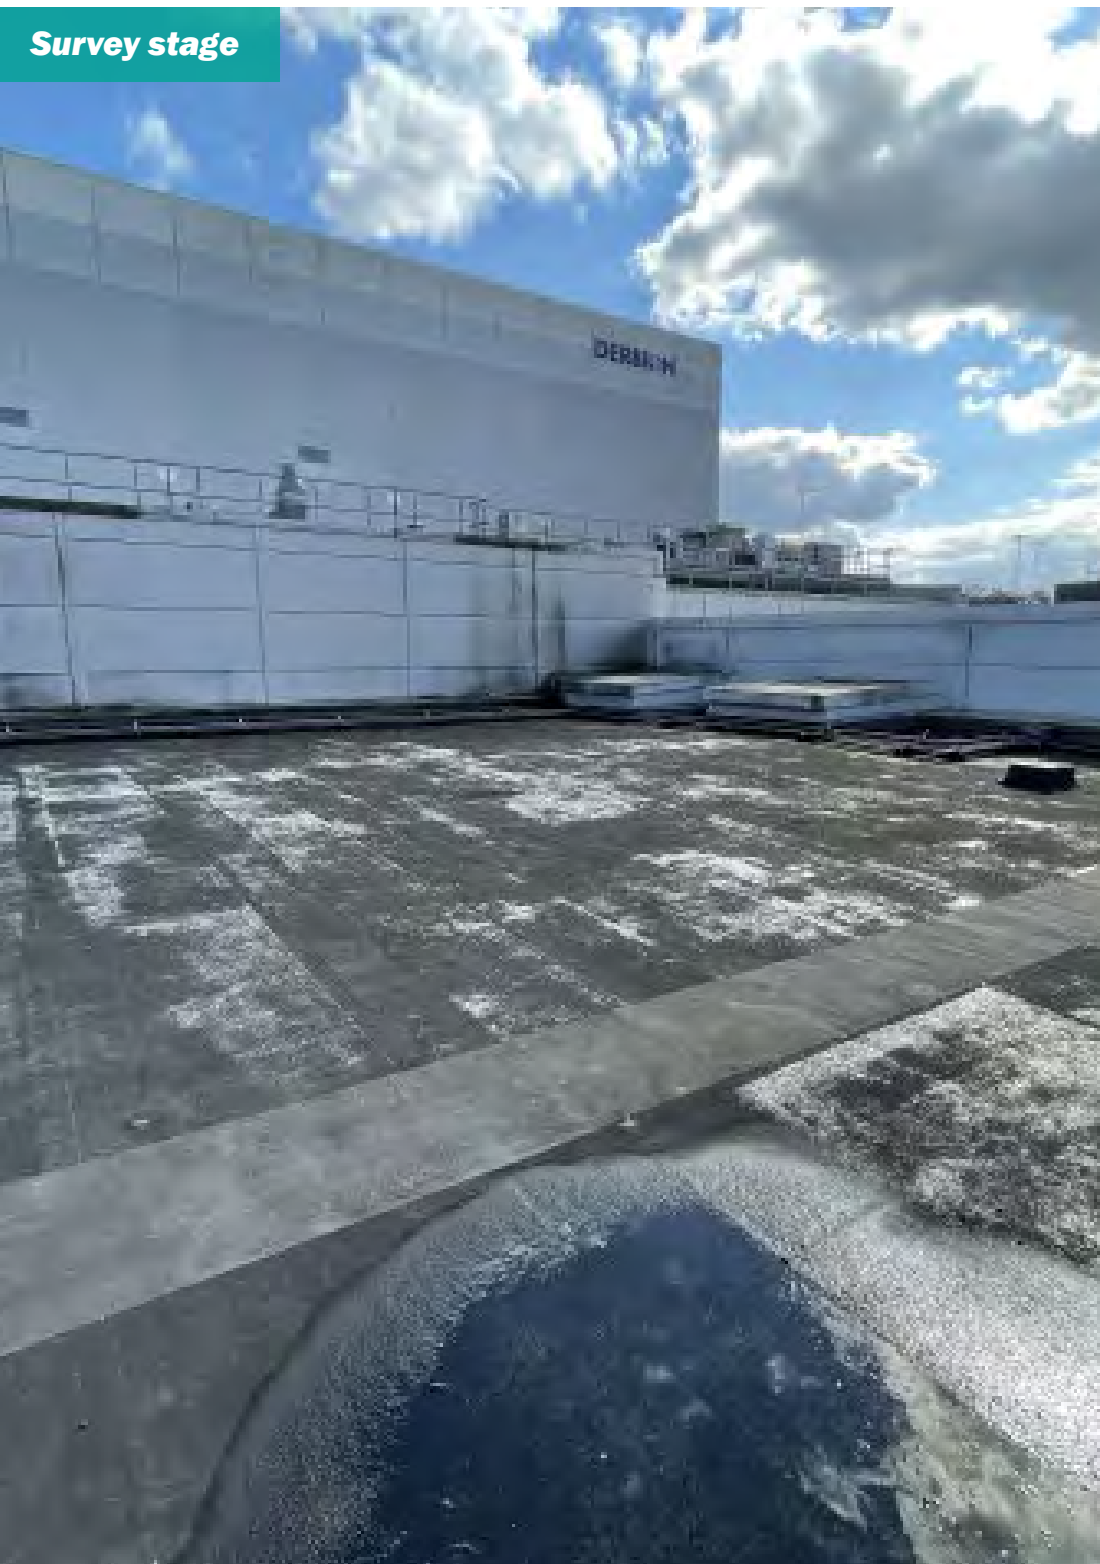
Survey stage

The roof above a retailer at Derbion Shopping Centre was experiencing persistent water ingress. The existing roof was an ageing felt system that had reached the end of its serviceable life, resulting in leaks that posed a risk to the retail environment below. Access and logistics presented additional challenges. The available compound area was extremely limited, and traditional scaffolding could not be mechanically fixed due to the presence of asbestos within the structure. Furthermore, existing rooftop plant restricted access and sequencing, requiring careful planning to minimise disruption to the live shopping centre.

To fully understand the extent of water ingress and avoid unnecessary full roof replacement, a [Roof Diagnostics](#) survey was undertaken using military grade thermographic camera technology. This allowed precise identification of wet and compromised areas within the roof build-up benefitting from significant cost savings, reduced disruption to the operations below and unnecessary waste to landfill. Initial works included the removal of the first section of rooftop plant to allow safe access. Due to the asbestos restrictions, a fully bespoke access and scaffolding solution was designed and installed, enabling works to proceed without penetrating the existing structure. Targeted strip-up was carried out in areas confirmed as wet by the diagnostics survey, ensuring only affected sections were removed. These areas were repaired and reinstated before overlaying the existing roof system.
