Case Study

# Centrale Shopping Centre | Plant Room

Croydon

Refurbishment

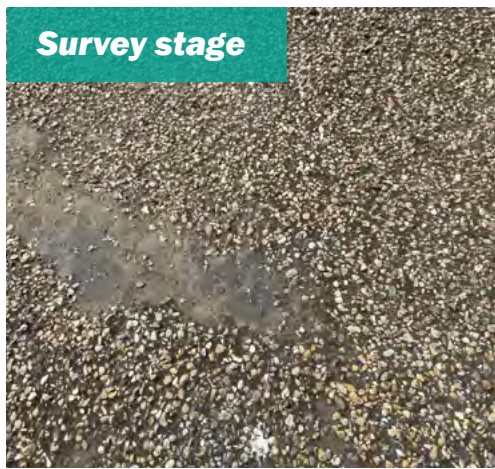
## Survey stage

A significant plant building situated on the roof of Centrale Shopping Centre was leaking.

The roof was covered in limestone chippings that made it near impossible to visually inspect and locate the source of the issue. Before any thorough investigation could be undertaken scaffolding was erected, and tonnes of limestone chippings were removed by a scarifying machine, manually bagged and hoisted down. This allowed for roof diagnostics to be carried out. Roof diagnostics entails initial core samples to evaluate, not only the build-up, but to establish moisture data benchmarks. Once complete a thermal scanning camera can then pinpoint areas of moisture and its severity to give data-led insights of problematic areas. Resulting in an informed cost-effective solution to refurbishment.

A comprehensive report and specification was produced by Tremco, which recommended an overlay of the existing 700m<sup>2</sup> roof to restore its waterproofing, and to replace, like for like, just 80m<sup>2</sup> of roof that was badly affected by water ingress. Some of the chippings were heavily embedded within the existing waterproofing. It was decided to line the roof with TremPly to deliver a coat-able surface that was compliant to Broof(t4) classification.

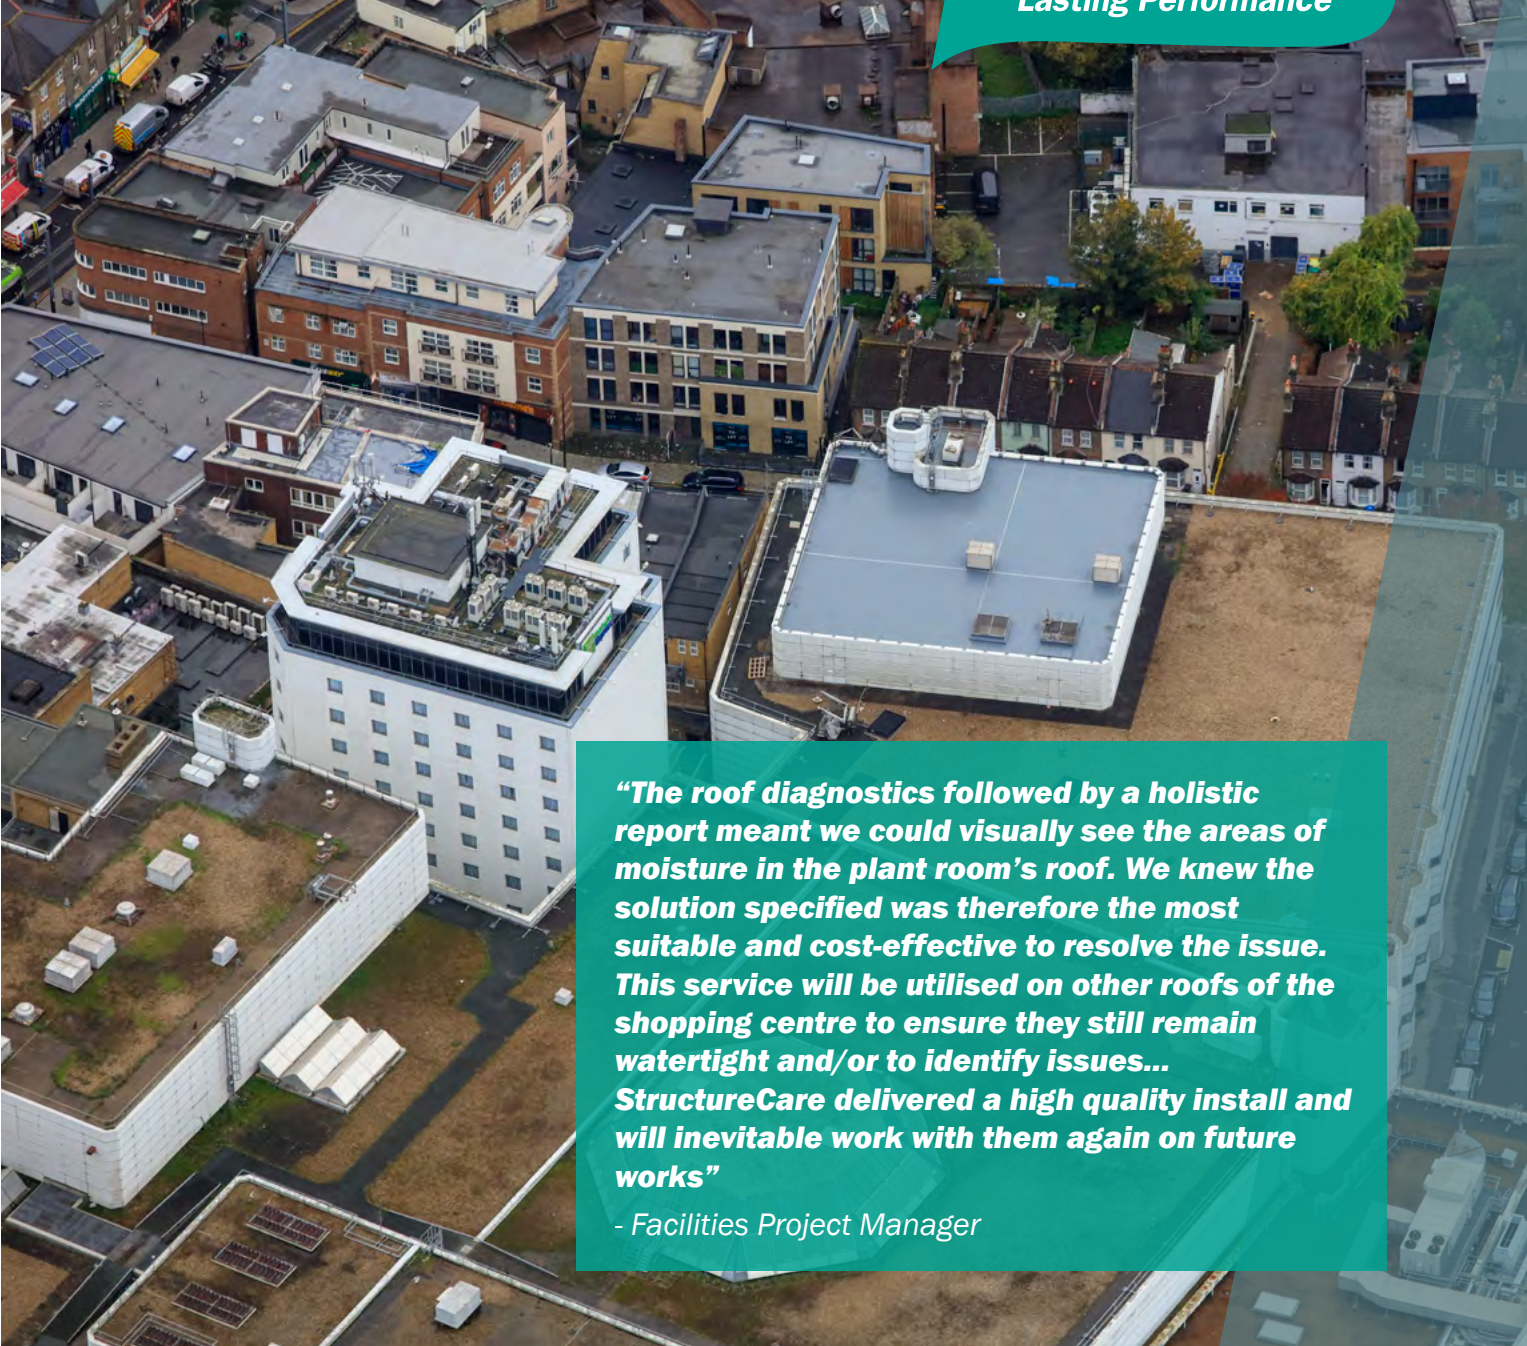
### Roof diagnostics - scan data

Thermogram T-01

Thermogram T-02

Thermogram T-03

Thermogram T-04

Thermogram T-05

Thermogram T-06

**“The roof diagnostics followed by a holistic report meant we could visually see the areas of moisture in the plant room’s roof. We knew the solution specified was therefore the most suitable and cost-effective to resolve the issue. This service will be utilised on other roofs of the shopping centre to ensure they still remain watertight and/or to identify issues... StructureCare delivered a high quality install and will inevitable work with them again on future works”**
