Case Study

# Aeroplane Engineering Plant

Eaton

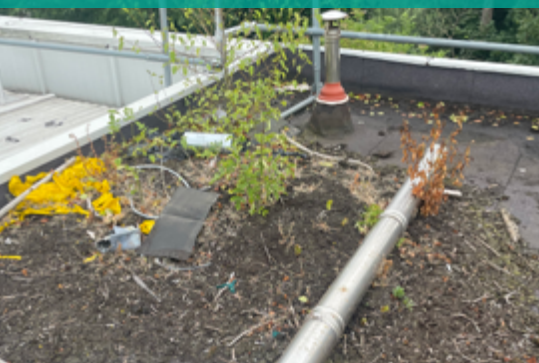
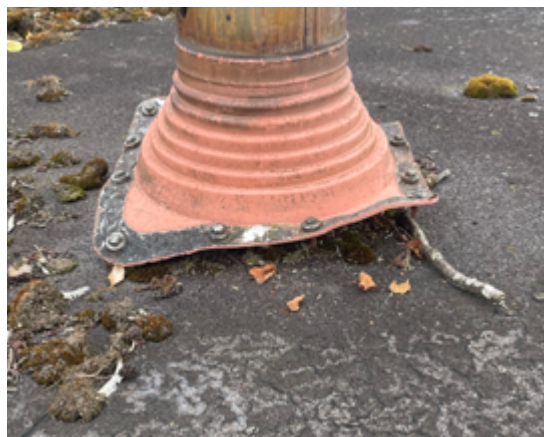
## Survey stage

The main roof comprised an ageing felt system that had developed extensive blistering. These blisters were allowing cracks to form, creating direct entry paths for water. In addition, a smaller metal composite roof was also leaking and required full refurbishment.

The first stage involved addressing the defects in the felt roof. Blisters were systematically opened, made good, and the surface fully prepared and washed to ensure suitability for overlay. Once prepared, the main roof was overlaid with the POWERply RBM Roof System, providing a robust and long-term waterproofing solution.

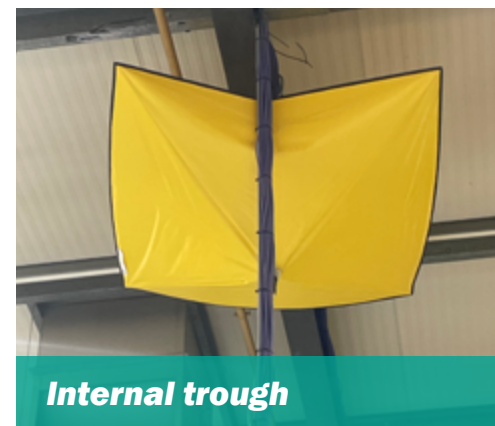
Multiple roof areas at an aeroplane engineering plant in Eaton was experiencing active water ingress, requiring immediate mitigation to protect sensitive operational machinery below. Temporary internal troughs had been installed to capture leaking water and prevent it from impacting equipment, highlighting the urgency of a permanent solution.

Internal trough

The completed refurbishment delivered fully watertight roof systems across both felt and metal roof areas, eliminating active leaks and removing the need for temporary internal water management measures.
